Assessment of Proposed Astera Development Project Site

On December 15, 2008 a TIDE team conducted a Rapid Assessment of the proposed Astera Development project site, located just south of Punta Negra (16.271532, -88.559915).

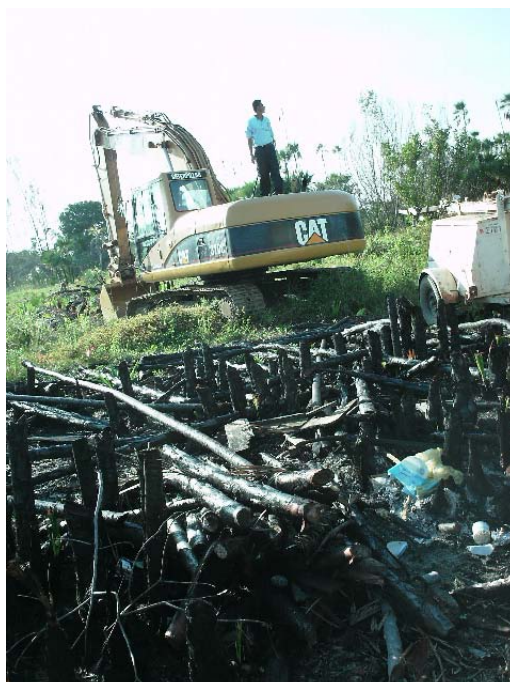
The proposed development area has already been disturbed, some of the vegetation has been removed or disturbed by fire, approximately 50 meters inland from the sand dune the vegetation has been cleared and overgrown. Further inland the dominant vegetation are palmetto stands recently burnt.

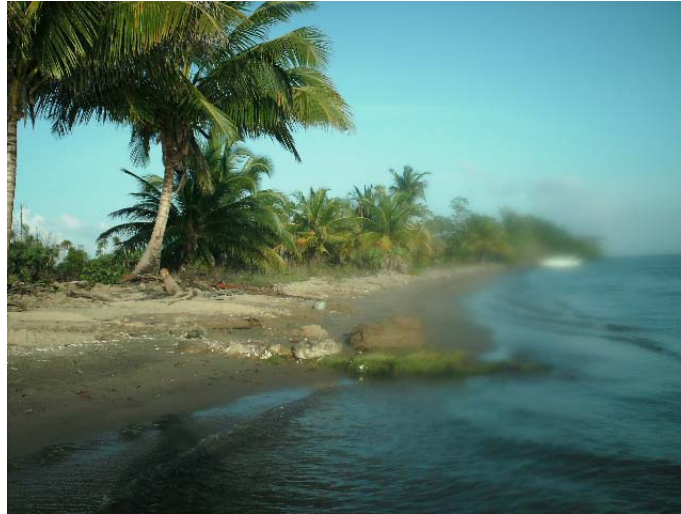
Within the first 50 meters inland the vegetation included a few cultivated fruit trees. These trees include: 1 mango tree, several citrus trees, a small cane patch, 2 almond trees and coconuts on the sand dune in front of the shoreline. The Native

vegetation of the area which was button wood and white mangrove was scarce, with the few existing trees damaged by fire. Several small ponds were identified within the area. These ponds were overgrown with aquatic grasses measuring 2-2.5 meters tall. Most of the cleared area had short grasses mixed with dandelion. The general ecosystem type of the area can be described as Tropical Littoral Forest and Beach Communities.

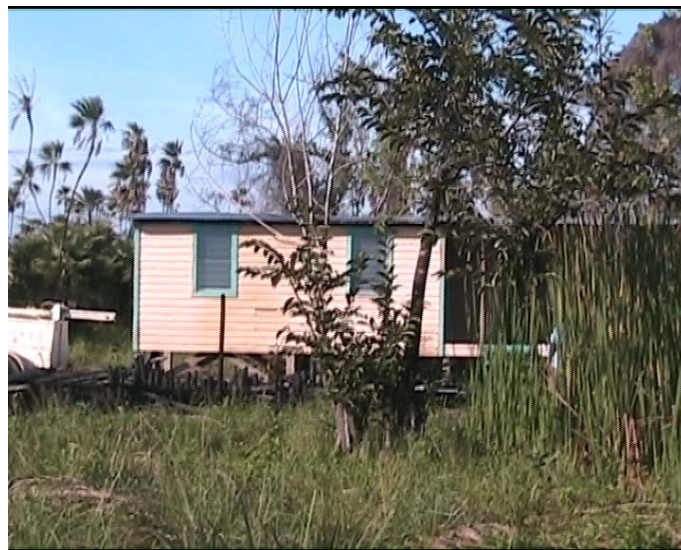
One small house was on the project site. The house was part of a fishing lodge in the past.

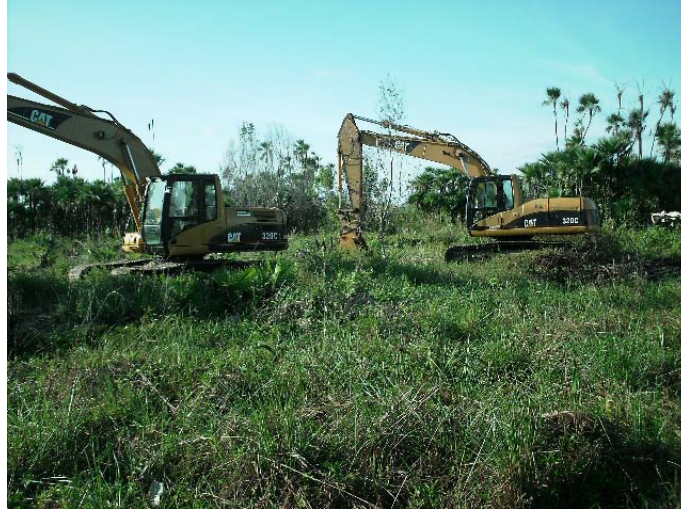
In front of the existing house are remnants of other structures colonized by termites. Equipments on site included two large excavators and a generator.

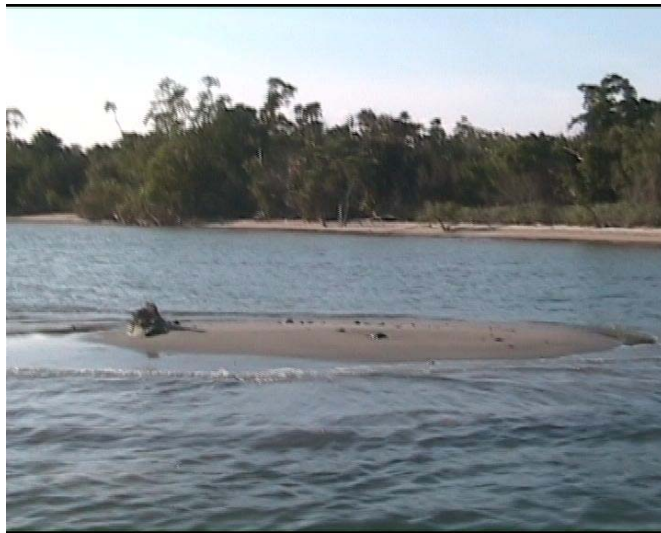
The channel running parallel to the shore was untouched, however, a channel running at right angles to this and into shore was newly dredged specifically to allow access for a barge carrying the 2 excavators. The area dredged was approximately 17m x 55m x 0.86m. The sand removed from the channel was piled to one side and broke the surface of the water.
